DEPARTMENT OF TRANSPORTATION**DIVISION OF ENGINEERING SERVICES**

Contract #: 04-0120F4Cty: SF/ALA Rte: 80 PM: 13.2/13.9File #: 69.28**WELDING INSPECTION REPORT****Resident Engineer:** Pursell, Gary**Address:** 333 Burma Road**City:** Oakland, CA 94607**Report No:** WIR-004248**Date Inspected:** 13-Oct-2008**Project Name:** SAS Superstructure**OSM Arrival Time:** 1330**Prime Contractor:** American Bridge/Fluor Enterprises, a JV**OSM Departure Time:** 2230**Contractor:** Zhenhua Port Machinery Company, Ltd (ZPMC), Changxing Island **Location:** Shanghai, China**CWI Name:** Xu Le Feng**CWI Present:** Yes No**Inspected CWI report:** Yes No N/A**Rod Oven in Use:** Yes No N/A**Electrode to specification:** Yes No N/A**Weld Procedures Followed:** Yes No N/A**Qualified Welders:** Yes No N/A**Verified Joint Fit-up:** Yes No N/A**Approved Drawings:** Yes No N/A**Approved WPS:** Yes No N/A**Delayed / Cancelled:** Yes No N/A**Bridge No:** 34-0006**Component:** OBG Fabrication**Summary of Items Observed:**

Heavy Bay 1

Heavy Bay 2

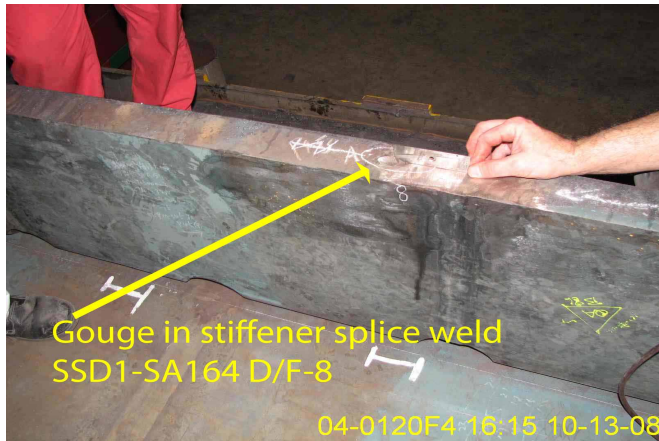
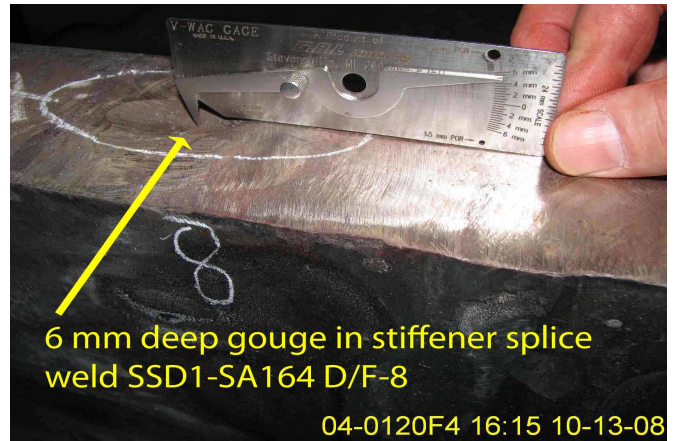
ABF informed the QA Inspector that ESD-1 Skin "D" stiffener to skin plate welds are ready for inspections and green tagging. The QA Inspector performed random visual inspections of ESD1 Skin "D" stiffener to skin plate welds and observed various weld locations that have areas in excess of 1 mm in depth below flush at the top of the complete joint penetration stiffener splice welds and some stiffener to skin plate welds have had the bottom toe ground and the weld profiles now have overlap conditions. The QA Inspector identified the outside weld of

stiffener D4 had 14 locations that need rework, including removal of weld spatter and cleaning of weld relief holes.

Between stiffener D2 and D3 the QA Inspector identified eighteen weld locations that need rework and between stiffener D1 and D2 a total of five weld locations were identified that require rework. ZPMC QC/CWI Xu Le Feng was informed of these problems. Note: ZPMC is in the process of welding upper stiffener connection plates and the stiffener to skin plates below these plates could not be inspected due to welding and grinding debris. All weld relief holes require grinding to obtain smooth clean weld surfaces. QA Inspector Mr. George Goulet also performed visual inspections of various stiffener to skin plate welds.
